Anwendungsbericht/User Application Report

AquaKat XL and XXL

Application in a hardening plant in Germany

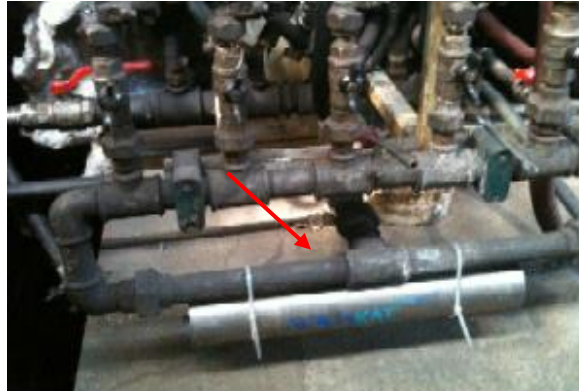
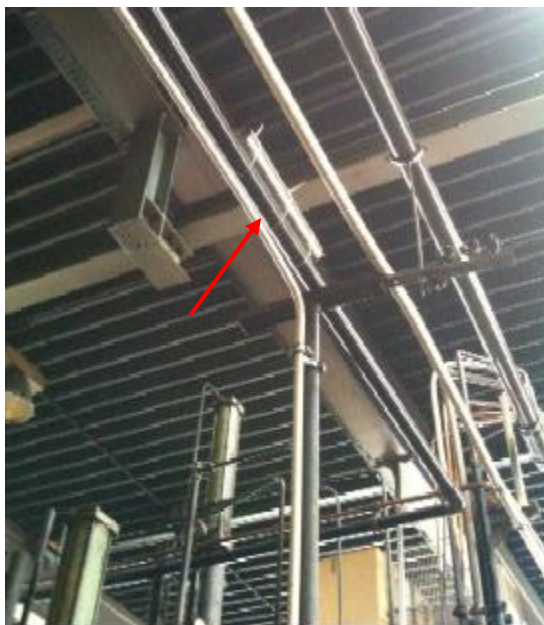
In July of 2009 an AquaKat XXL was installed on the central cooling water manifold and one AquaKat XL each on the most affected furnaces.

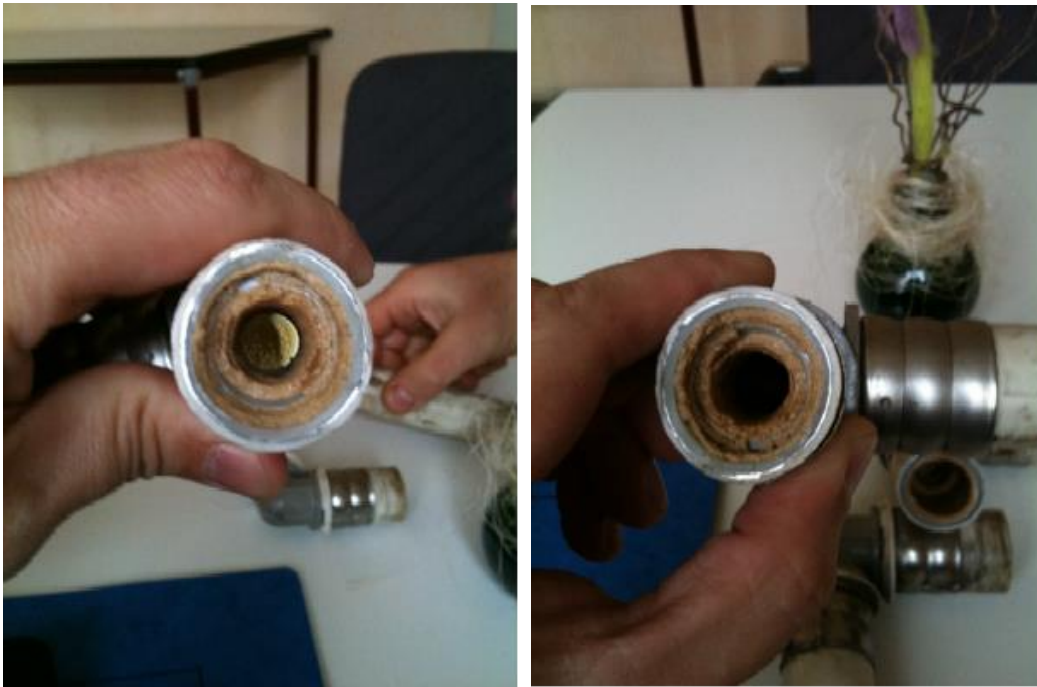
Condition of the pipe after approximately 3 months of operation before using AquaKat

Every three or sometimes even every two months the machines' cooling pipes are so badly affected by limescale that they close up altogether and it is no longer possible to cool the furnaces.

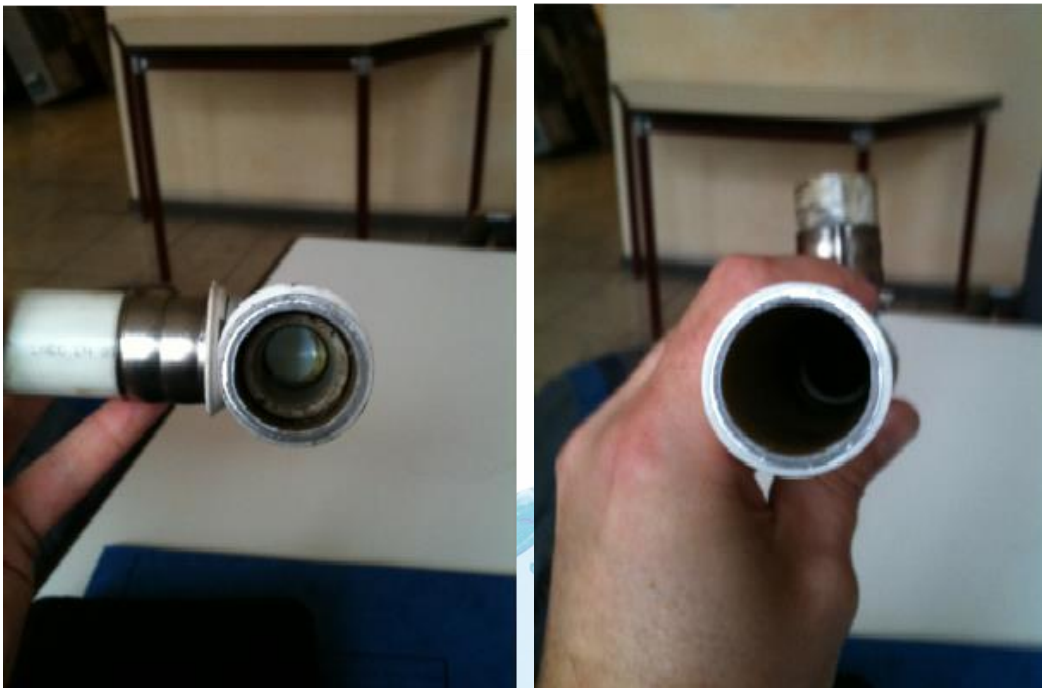
Condition of the pipe after 3 months of operation with AquaKat!

Since the AquaKats were fitted, it has not been necessary to descale the systems once!

The cooling system has now run perfectly since July 2009 and has not needed to be descaled since.
